MISSISSIPPI ENVIRONMENTAL GEOLOGY

David T. Dockery III and David E. Thompson

Mississippi Department of Environmental Quality
Office of Geology
Second Edition, 2019

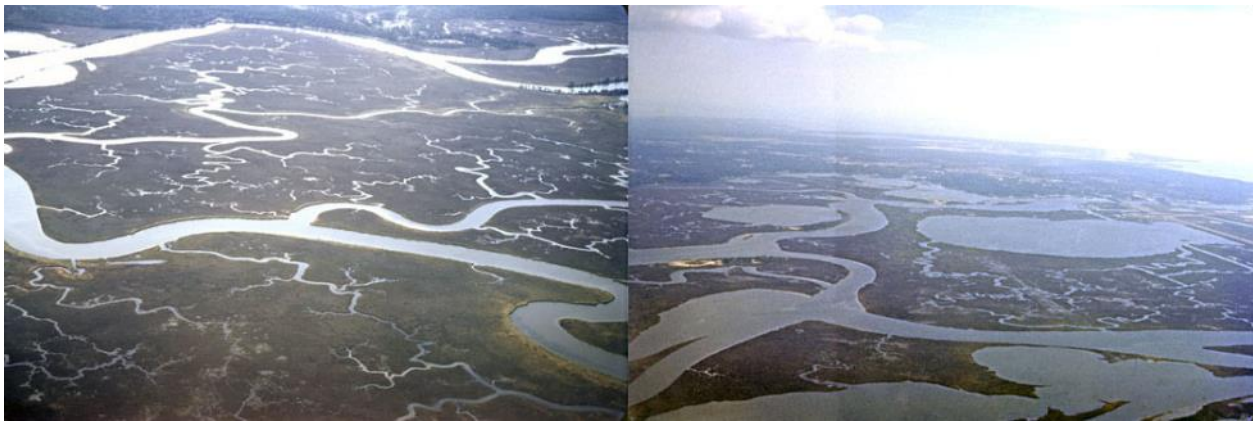
Figure 614. At left, tidally-influenced saltwater marshes of the Pascagoula River estuary in Jackson County, Mississippi. At right, tidal marshes on the lower Pascagoula River with Marsh Lake at upper right and the coastline beyond. Pictures taken in November of 1973. Image 1842.

graduate students and the Ole Miss airplane before the flyover. **Figure 613** shows the meander belt of the Pascagoula River and the river's upper estuary. **Figure 614** shows the lower estuary of the Pascagoula within view of the coastline. **Figure 615** shows the mouth of the Pascagoula River and the beach and sand shoals at Belle Fontaine Point. **Figure 616** shows the salt-water marsh behind the beach at Belle Fontaine Point and an eroded beach nearby. **Figure 617** is the *Environmental Geologic Map, Jackson County, Mississippi*. A digital copy of this map was made available to us by Charles Swann of the Mississippi Mineral Resources Institute at the University of Mississippi.

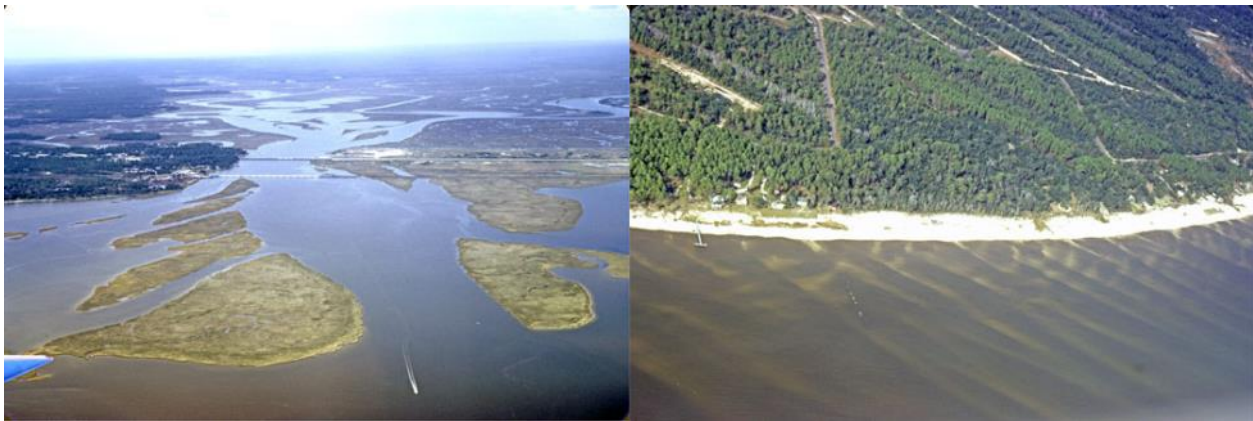
Figure 615. At left, tidal marsh on Belle Fontaine Point in Jackson County, Mississippi. At right, retreating shoreline and black beach where erosion has exposed marsh sediments underlying the beach sand at an unknown location in Jackson County. Pictures taken in November of 1973. Image 1843.

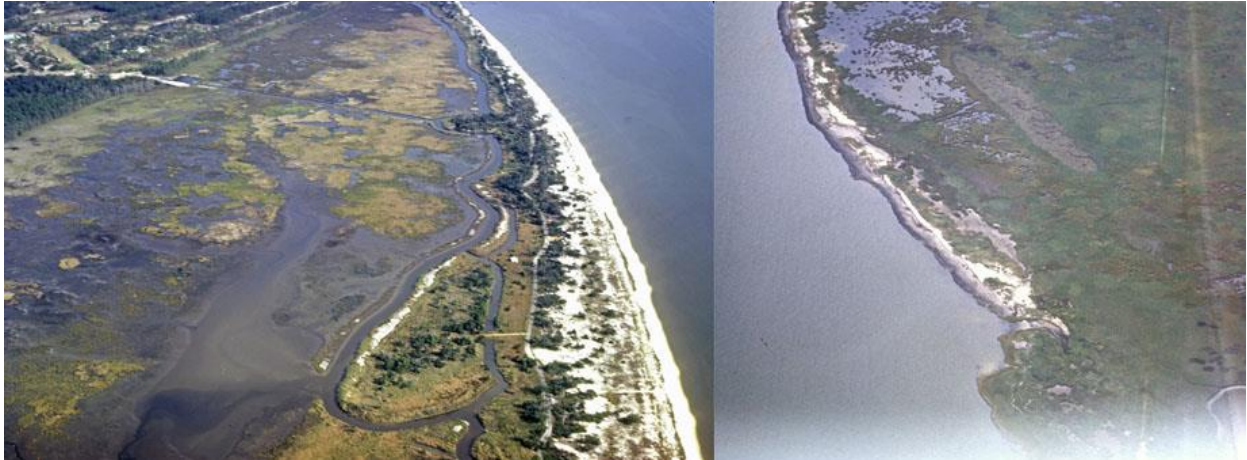
Figure 616. At left, tidal marsh on Belle Fontaine Point in Jackson County, Mississippi. At right, retreating shoreline and black beach where erosion has exposed marsh sediments underlying the beach sand at an unknown location in Jackson County. Pictures (slides 8-18 and 7-19) taken in November of 1973.

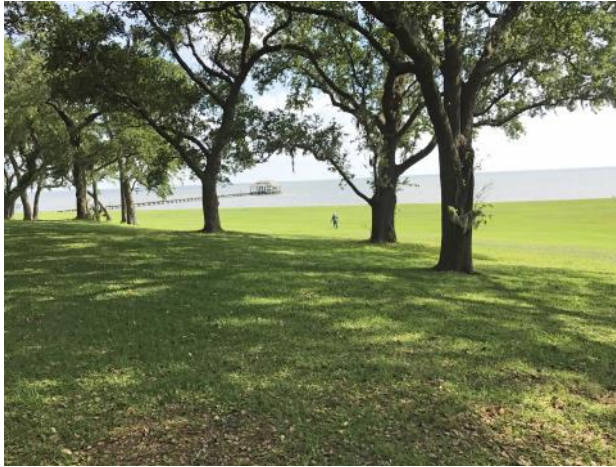
Figure 619. Pamlico Terrace scarp at Davis Point southeast of Ocean Springs. The grassy plain in front of the scarp is post-Katrina fill. Photograph by James Starnes, May 10, 2017.

geology of Mississippi's Gulf Coast. Coastal terraces, those terraces running parallel to the coast, include the Pamlico Terrace at 0 to 30 feet above mean sea level (msl) (**Figure 619**), Big Ridge Terrace at 30 to 50 feet msl (**Figure 620**), and Good Hope Terrace at 50 to 110 feet msl (**Figure 621**). River terraces, those terraces running parallel to river courses, include the Wade Terrace at 30 to 50 feet msl (**Figure 622**), Big Point Terrace at 50-80 feet msl (**Figure 623**), Hurley Terrace at 80 to 110 feet msl, Harleston Terrace at 110 to 130 feet msl, and Movella Terrace at 130 to 150 feet msl. Bedrock formations exposed at the surface in the county include the Pliocene Graham Ferry Formation and the Late Miocene Pascagoula Formation.

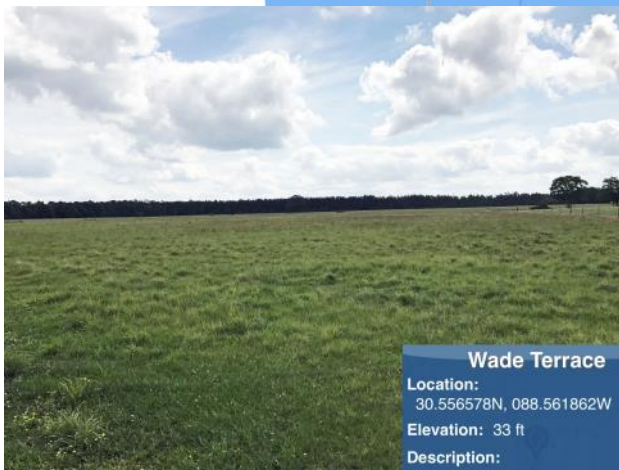
Figure 622. Wade River Terrace at 30 to 50 feet above mean sea level. Photograph by James Starnes, May 11, 2017.

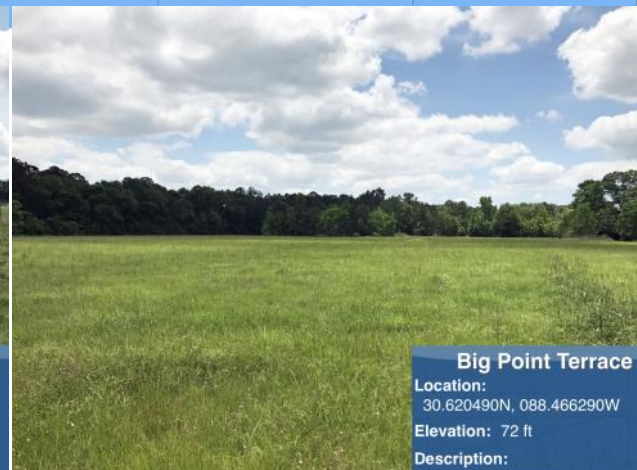
Figure 623. Big Point Terrace at 50 to 80 feet above mean sea level. Photograph by James Starnes, May 11, 2017.

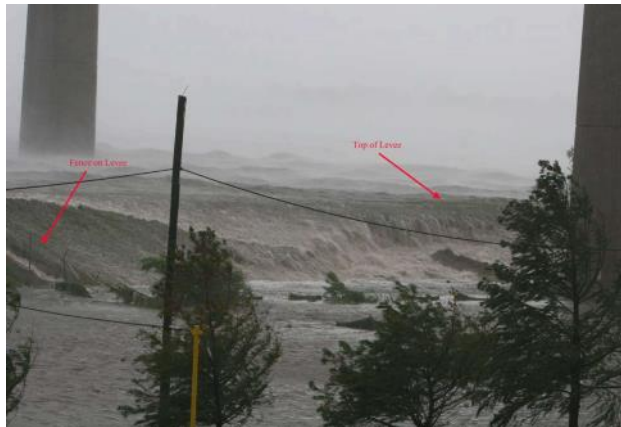
Figure 634. Katrina storm surge with high waves topping the levee on the north side of the Intracoastal Waterway right under the Paris Road/Highway 47 bridge. Picture taken by someone at the Entergy Power Plant in the early morning of August 29, 2005. Image 1810.

ures during Hurricane Katrina's storm surge. When Hurricane Katrina struck the Gulf Coast on Monday August 29, 2005, NOAA's buoy about 50 miles off the mouth of the Mississippi River recorded 40-foot waves at 3:00 AM; two hours later these waves reached a height of 46 feet. Katrina's storm surge of some 18 feet, two feet higher than the levee tops in eastern New Orleans, arrived in the city from the Gulf of Mexico by way of the Intracoastal Waterway (Figure 634), overtopping the waterway's levees along the way. Levees along the New Orleans Industrial Canal connecting the Mississippi River and Lake Pontchartrain were overtopped and breached by 7:00 AM, flooding areas north of the French Quarter. A catastrophic failure of the canal's eastern floodwall and levee devastated the city's Lower Ninth Ward.

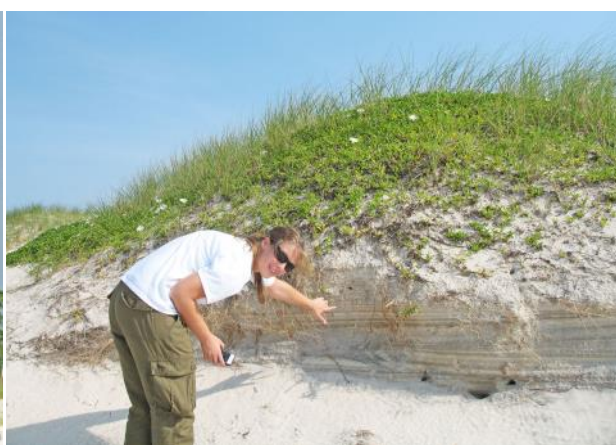
Figure 639. U.S. Army Corp of Engineers employee pointing out dark bands of heavy minerals in the Horn Island beach deposits. Picture by Richard Ball, June 25, 2013. Image 2496.

Mississippi's barrier islands formed between 5,000 and 3,500 years ago when the rate of post-Pleistocene sea-level rise slowed, and when the coastline was located approximately where it is today. Dear, Round, and eastern Dauphin islands were Pleistocene high grounds that were surrounded by rising Gulf waters. Eastern Dauphin, Petit Bois, Horn, Ship and Cat islands were formed by the westward long-shore transport of sand from Dauphin Island at the mouth of Mobil Bay. Mobil Bay sands were derived from an Appalachian Piedmont source and contained valuable heavy mineral deposits as seen in the dark bands within Horn Island beach sands (**Figure 639**). Horn Island has shifted its location over historical times as shown in **Figure 640**.

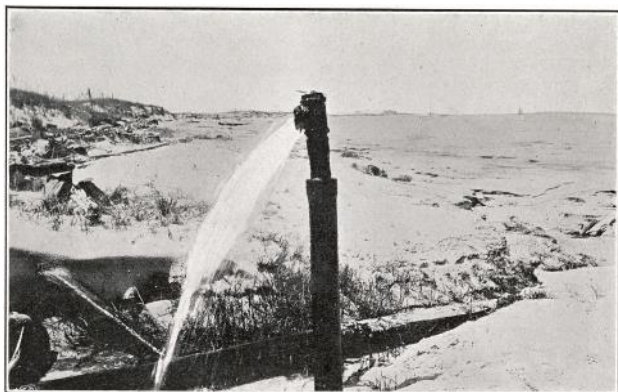
Figure 644. Flowing artesian well in the Graham Ferry aquifer at Ship Island as illustrated by Lowe (1915) in Mississippi Geological Survey Bulletin 12, page 113, figure 10. Image 2544.

Freshwater aquifer sands are present below Horn Island in the Graham Ferry aquifer. This aquifer is confined by fine-grained beds above and is under an artesian pressure that has historically produced flowing wells at the surface (**Figure 644**). Confining beds and artesian pressure make it less likely that groundwater resources in the Graham Ferry will be adversely affected by surface contaminants. On June 25, 2013, Army contractors (**Figure 645**) resampled the area of the first preliminary positive test for mustard gas and found no contamination.

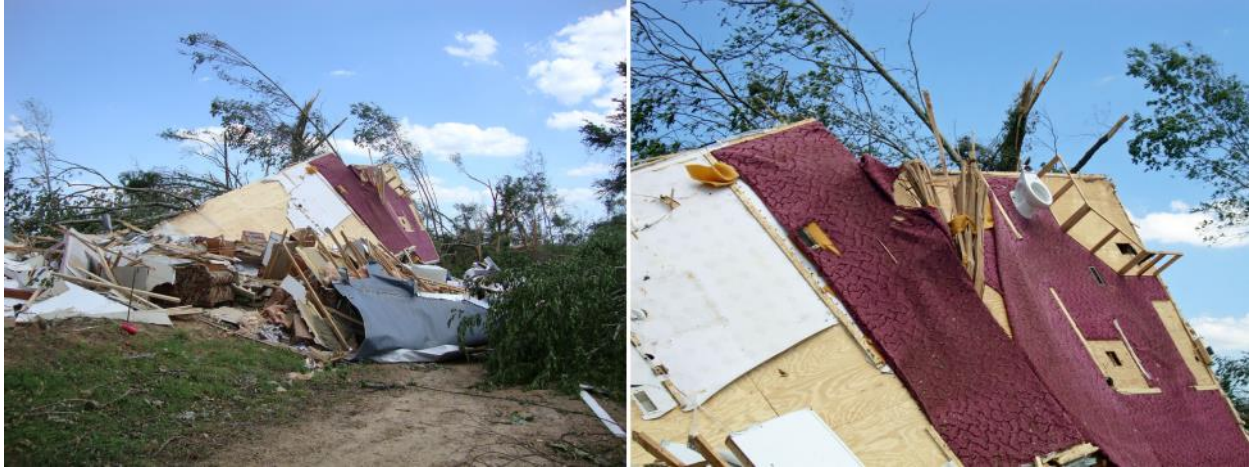
Figure 647. The floor of a mobile home west of Highway 49 in Yazoo City impaled on the splintered trunk of a tree. Pictures were taken on April 25, 2010. Image 2547.

ord for the state), and a path 140.25 miles, ending north of Sturgis, Mississippi. The storm was on the ground for nearly 3 hours. **Figure 647** shows the floor of a mobile home in Yazoo City impaled on a shredded tree trunk. **Figure 648**, at right, shows a car and dog house untouched in the midst of the devastation.

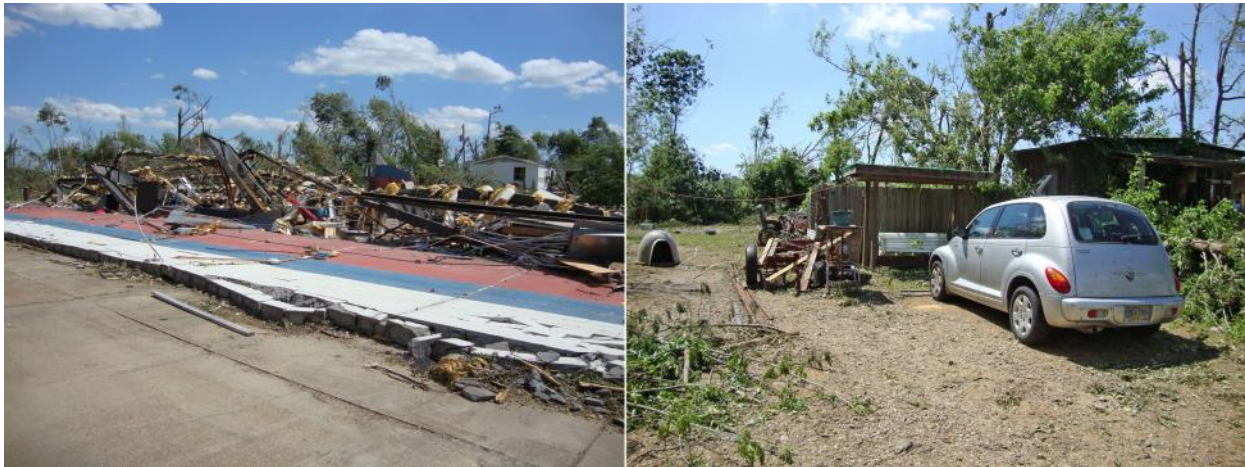
Figure 648. Left, behind the rubble of an old car dealership and broken trees is a modest house still standing (though the furniture was sucked out by the storm) west of Highway 49 in Yazoo City. Right, behind the house at left is a car in the eye of the storm untouched and an igloo dog house unmoved. Pictures were taken on April 25, 2010. Image 2548.

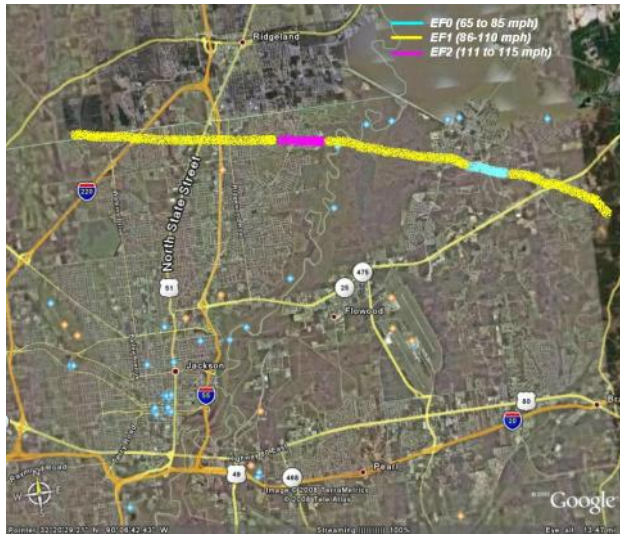
Figure 649. Tornado track across north Jackson on April 4, 2008. Image 2549.

A modest size tornado that crossed north Jackson on April 4, 2008, was awarded \$3.4 million in federal funding for debris removal (**Figure 649**). The tornado hit as 1,500 students from around the state were participating in a Children's Educational Fair at the State Agricultural Museum not far from the storm track. Just north of the museum, hail-laden wind damaged 75 new car at Watson Quality Ford, blowing the windows out of most of them. The damage estimate from this storm was said to rank as Jackson's third most costly disaster since the Pearl River Flood in 1979 and the burning of the city by Sherman in 1863.

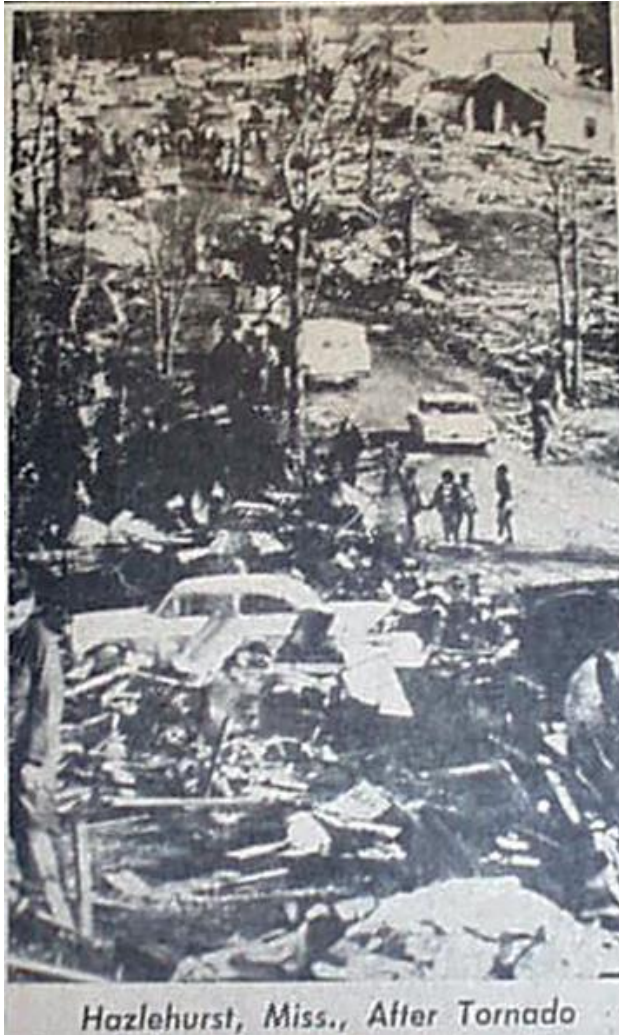
Figure 651. United Press International photograph of tornado damage in Hazlehurst on January 23, 1969. Image 2567.

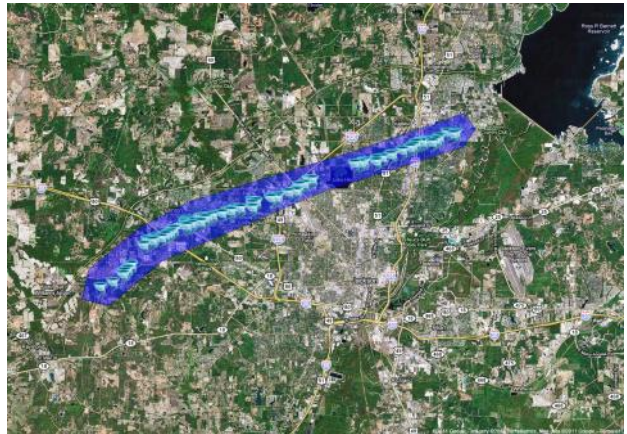
Figure 653. Path of the F3 Clinton Tornado on the morning of April 15, 2011. Image 2551.

ing its winds between a daycare with 150 children and an elementary school with 450 children (figures 653-654).

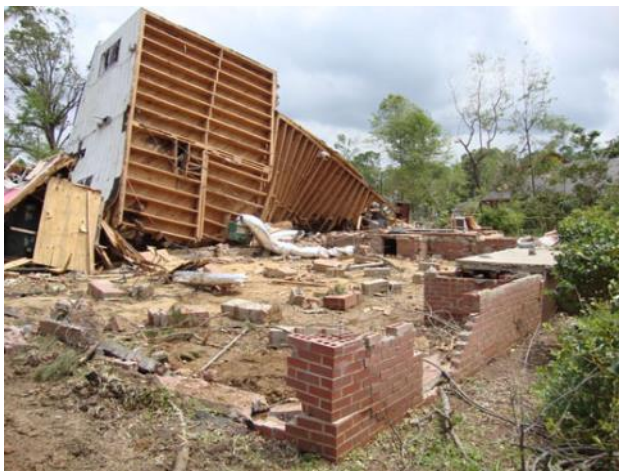
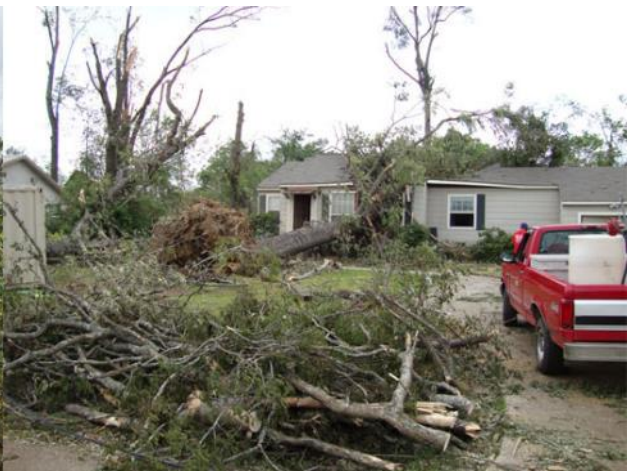
Figure 654. Damage in the Lakeside Subdivision south of Highway 80 in Clinton. At left, a home was ripped from its foundation; the 84-year-old owner of the flipped house was pulled out of the rubble with only a broken nose. At right a home was cut in half by a fallen tree. Pictures were taken April 18, 2011. Image 2552.

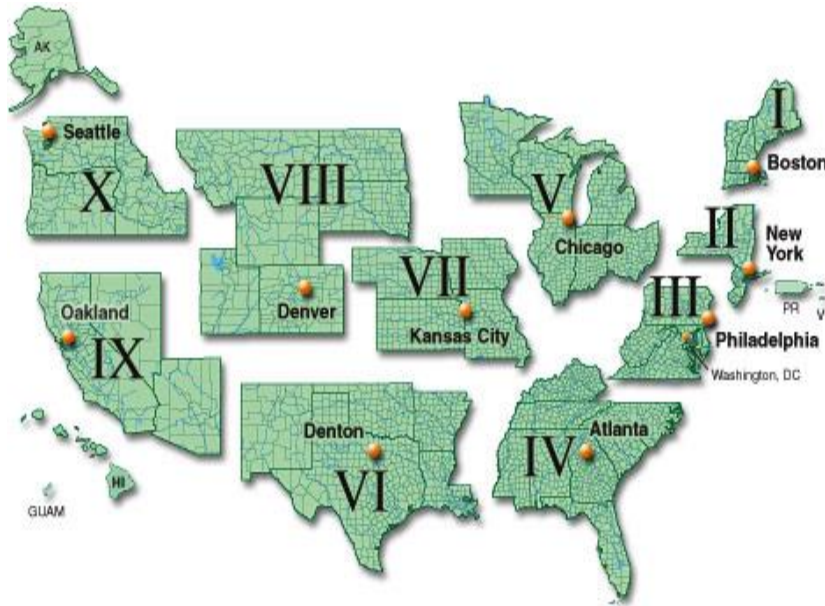
Figure 656. FEMA regions map. The agency has an annual budget of \$13 billion that is used and distributed to different states according to the emergencies that occur in each one. Image 2554.

overwhelms the resources of local and state authorities. The governor of the state in which the disaster occurs must declare a state of emergency and formally request from the president that FEMA and the federal government respond to the disaster. A governor's declaration is not required when an emergency or disaster takes place on federal property or assets. **Figure 656** shows FEMA's ten regional contact areas and headquarters.

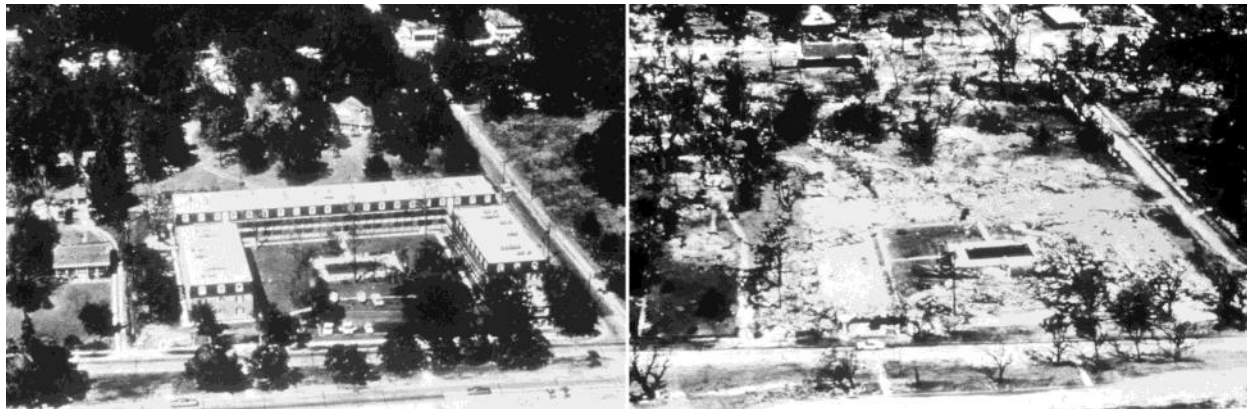
Figure 658. The Richelieu Mannor Apartments in Pass Christian, Mississippi, before (left) and after (right) Hurricane Camille. Twenty three people were staying at the apartments during the storm; eight died. Image 2555.

in which the apartments were destroyed and just one person survived. The amazing true story is that of the 23 people at the apartments, but only eight died in the storm (**Figure 658**). One survivor denied the party story, but Bobbie Morali (personal communication), whose family lived a block away from the hotel and evacuated before the storm made landfall, said that a policeman later told them he stopped by the hotel twice trying to get everyone to evacuate. On the second warning he told them he wouldn't be coming back. The policeman noticed that those who stayed had been drinking.

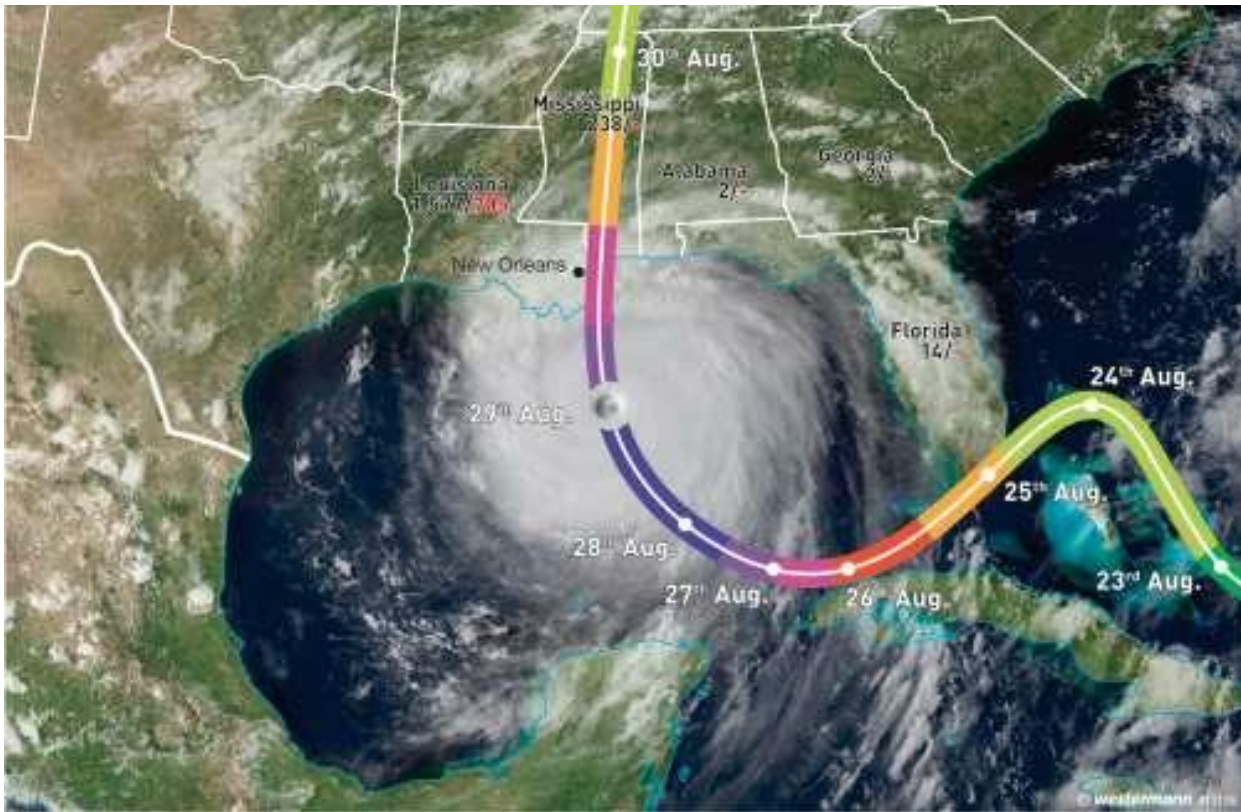
Figure 659. Day by day track and intensity of Hurricane Katrina from August 23 to August 30, 2005. On August 28 and 29, Katrina was a Mississippi storm. Image 2569.

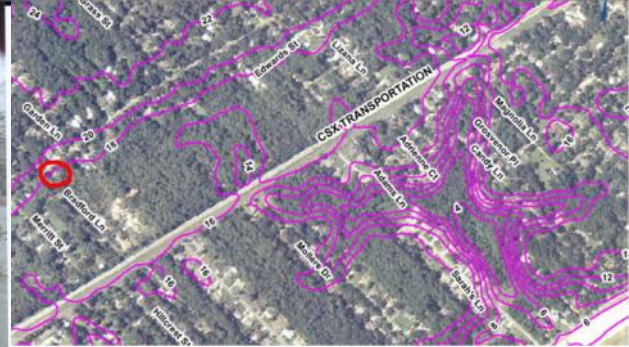
Figure 662. Red circle at left marks the spot of the Bradford's home on the 18-foot contour above sea level in Waveland, Mississippi. Image 2572.

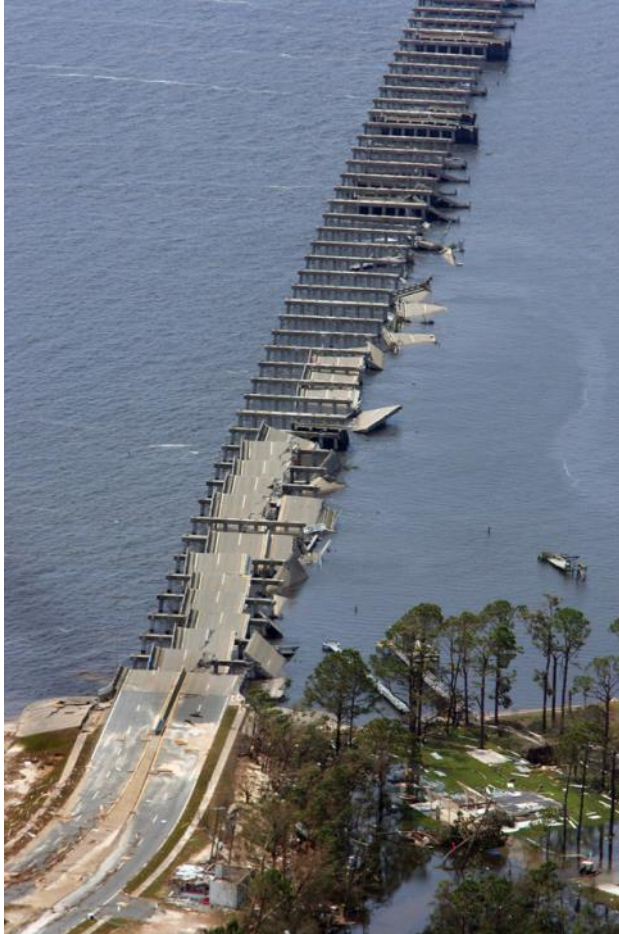
Figure 667. The Highway 90 bridge over Bay St. Louis in Pass Christian, Mississippi, is folded and destroyed from Katrina's storm surge, August 30, 2005. Image 2577.

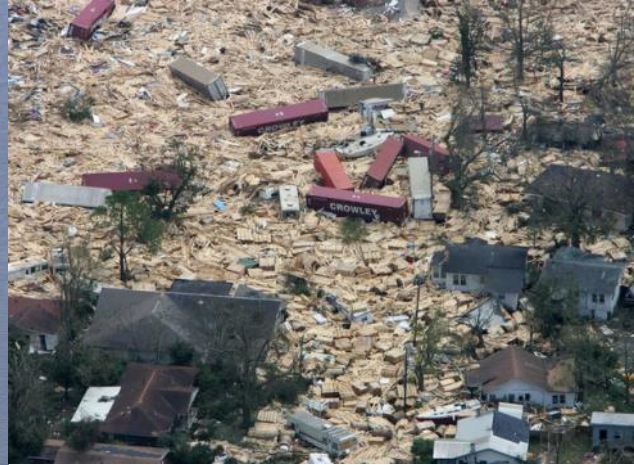
Figure 668. A residential area in Gulfport, Mississippi is inundated with shipping containers, RVs, and boats washed ashore by Hurricane Katrina as seen on August 30, 2005. Image 2578.

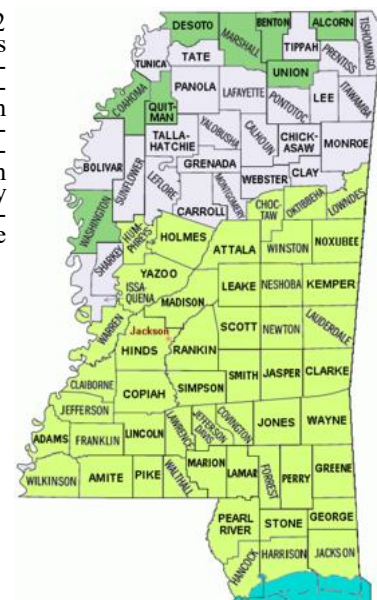
Figure 670. All 82 Mississippi counties were declared disaster areas after Katrina. The lower 49 in light green were given full disaster assistance. Dark green areas were given only public assistance Category A/B. Image 2580.

Hurricane Katrina's strongest winds did much damage in Louisiana and Mississippi as shown in **Figure 669**. MDEQ Office of Geology Katrina responder James Starnes characterized the wind damage this way: "Katrina followed Highway 49 to Hattiesburg and took the Interstate 59 exit to Meridian." All 82 Mississippi counties were declared disaster areas (**Figure 670**). Wind damage cut power to most of southern and central Mississippi. Without power, gas stations could not pump gas, and those that could soon ran out of supply, creating a gasoline shortage that outlasted the power outage. In the midst of disarray in Central Mississippi, MDEQ sent a response team to the Gulf Coast to assist with debris removal. On September 3, 2005, MDEQ Executive Director Charles Chisolm issued a "Hurricane Katrina Disaster Debris Management Response, Vegetative Debris Disposal" for the hardest hit southern and southeastern counties to facilitate the management, burning,

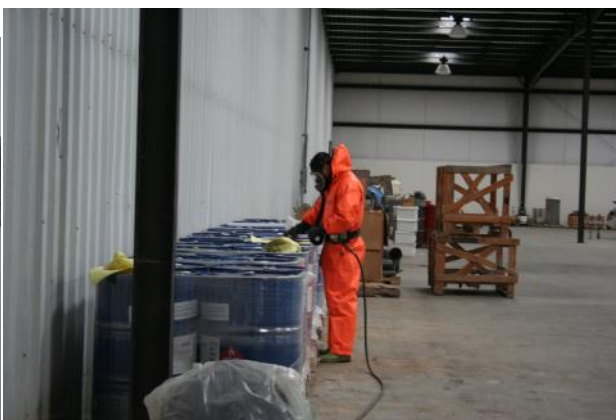
Figure 680. Hazardous materials abandoned at facility past shelf life and unstable and explosive. Drums had to be opened and stabilizer added to prevent uncontrolled polymeric reaction before they could be shipped for disposal. Image 2594.

Starnes was also involved in finding new staging areas environmentally appropriate for household goods in Hancock County. Wetland areas were excluded from this use, and only high and dry ground was acceptable for this Class II material. Every sandpit in the coastal area was used for the permanent disposal of Class I (reduced vegetative debris; **figures 678-679**) and Class II material. Hazardous materials were shipped to appropriate disposal facilities (**Figure 680**).

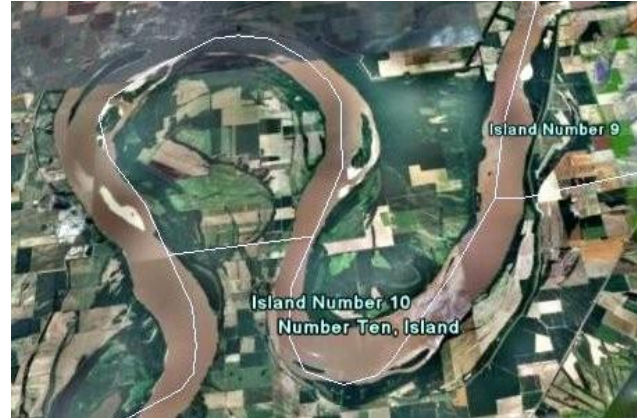
Figure 691. Locations of Island 9 and Island 10 on the Mississippi River in the February 7, 1812, earthquake (showme.net/~fkeller/quake/mississippi_river_ran_backward.htm). Image 2605.

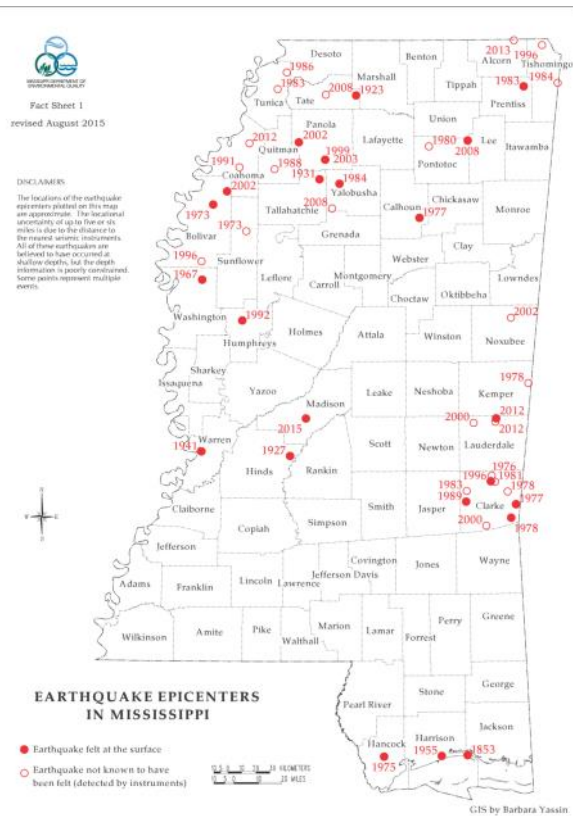
Figure 695. Earthquakes originating within Mississippi. Image 2609. From MDEQ Office of Geology Fact Sheet 1 by Michael B. E. Bograd, 2015.

The map in **Figure 681** indicates that earthquakes have occurred throughout Missis-

sippi. It is expected that earthquakes of low magnitude will continue to occur. Many earthquakes in neighboring (and distant) states have been felt in parts of Mississippi. However, the greatest risk to Mississippi from earthquakes is from a strong earthquake in the New Madrid Seismic Zone, the southern end of which is about 40 miles from the northwest corner of Mississippi. The great New Madrid earthquake series of 1811-1812 included at least four shocks strong enough to shake northern Mississippi at damaging intensities and be felt throughout the state. The 1843 earthquake at the southern end of the zone shook the northern third of Mississippi strongly enough to cause damage. People in Mississippi should take precautions for another strong earthquake on the New Madrid Seismic Zone.

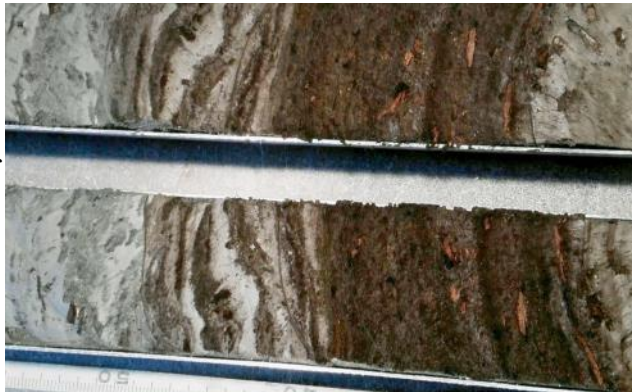
Figure 698. Vibracore containing the peat deposit overlying the submerged forest. Ancient pollen in the peat shows a transition from forest at the bottom of the core to marsh grasslands at the top. From Raines, 2017. Image 2612.

pollen and the upper peat to be dominated by grass pollen such as sedge. This sequence indicates that rising sea level, at a rate of some 75 feet per thousand years, killed the forest and

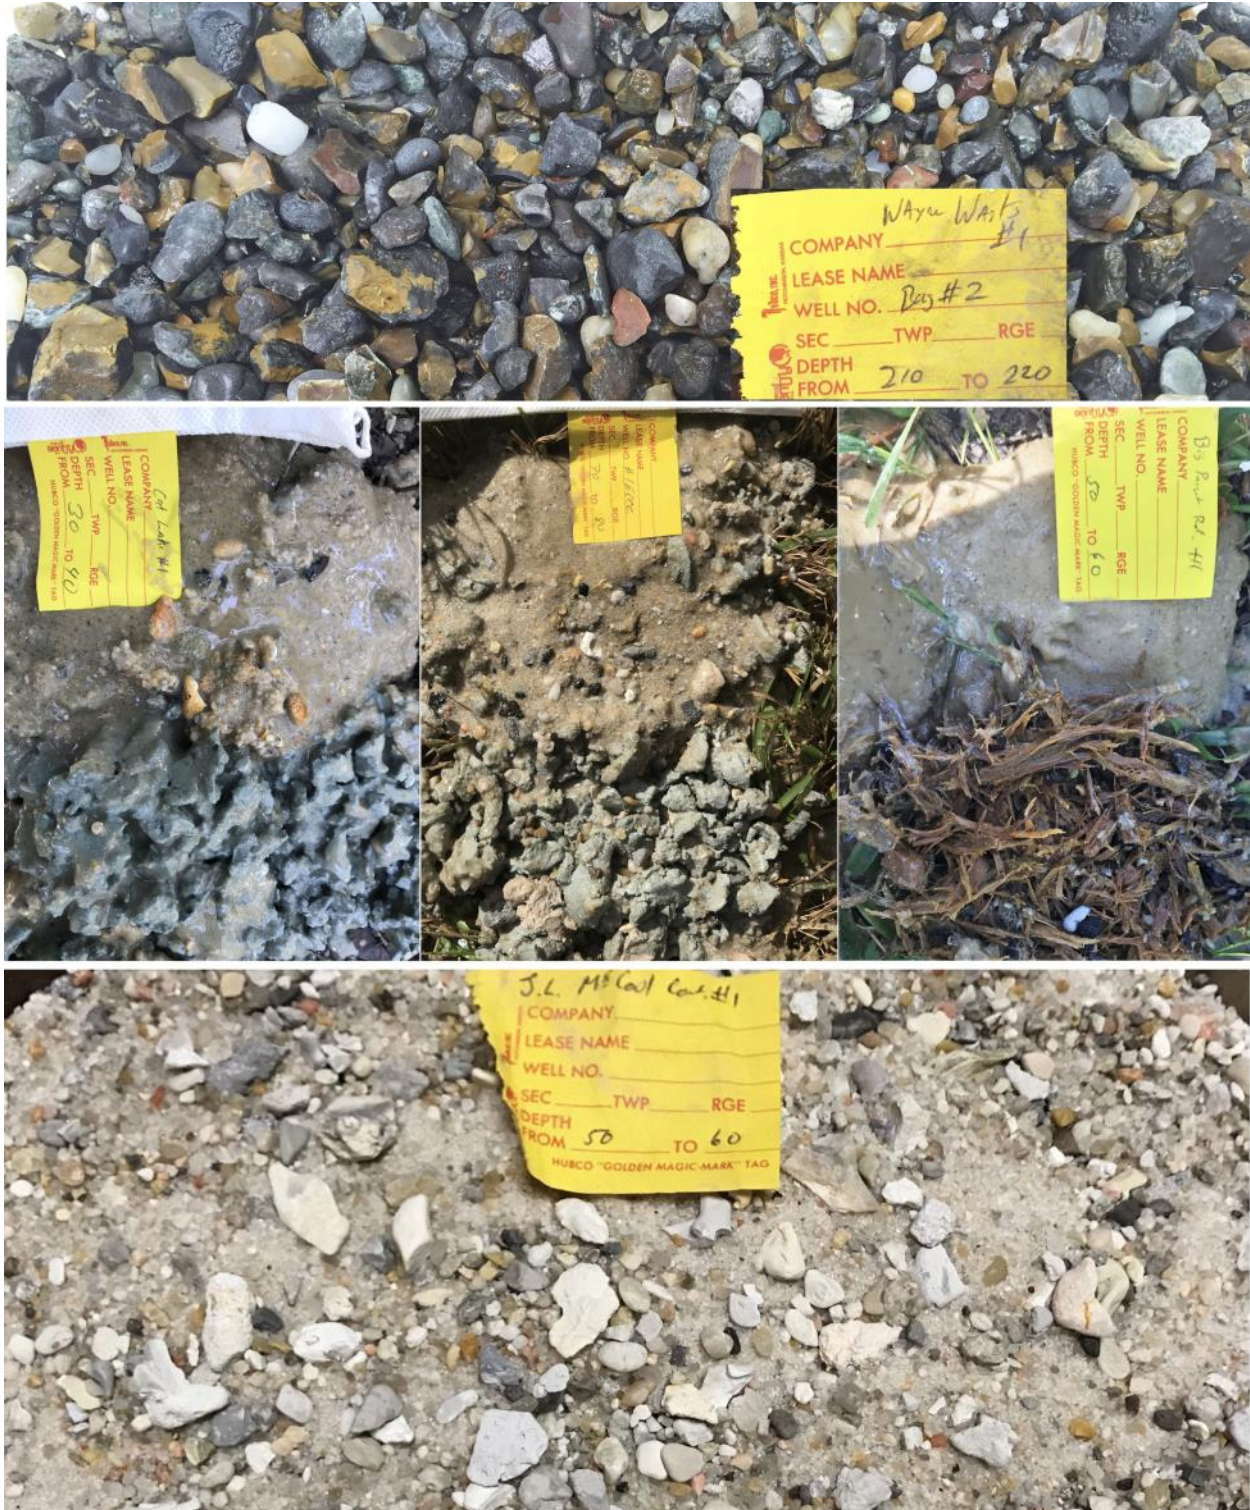
Figure 705. Test hole samples from Jackson County, Mississippi. At top is unweathered pea gravel from the Graham Ferry Formation. At middle left is the contact between the Pascagoula River alluvium and clay in the Graham Ferry Formation in the #1 MDWFP Cat Lake test hole. At middle middle is the contact of the Wade Terrace with the Graham Ferry Formation at 75 feet below surface level and 23 feet below seal level, where the terrace fill an ancient valley. At middle right are wood fragments of a four-foot thick log at a depth of 53 feet below the surface and 18 feet below sea level in Wade Coastal Terrace. At bottom is the highly weathered tripolitic gravel of the Pamlico Coastal Terrace from a depth of 50 to 60 feet below the surface..

Figure 705 at top shows unweathered pea gravel characteristic of the Graham Ferry Formation. At bottom, the figure shows the highly weathered tripolitic gravel of the Pamlico Coastal Terrace. In the middle from left to right is the contact of the Pascagoula River alluvium with clay of the Graham Ferry Formation at 35 feet below surface level, the Wade River Terrace contact with the Graham Ferry Formation at a depth of 75 feet below surface level, and a four-foot thick log encountered at a depth of 53 feet below the surface and 18 feet below sea level.

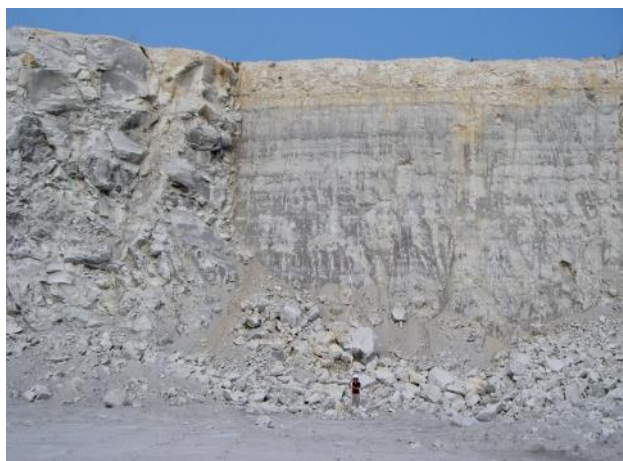
Figure 714. George Phillips holding survey rod in front of a vertical joint plane in the Muldrow Member of the Demopolis Formation in the high wall of the Holcim Inc. Artesia Plant chalk quarry near Artesian in Lowndes County, Mississippi. Picture taken on August 24, 2007. Image 932.

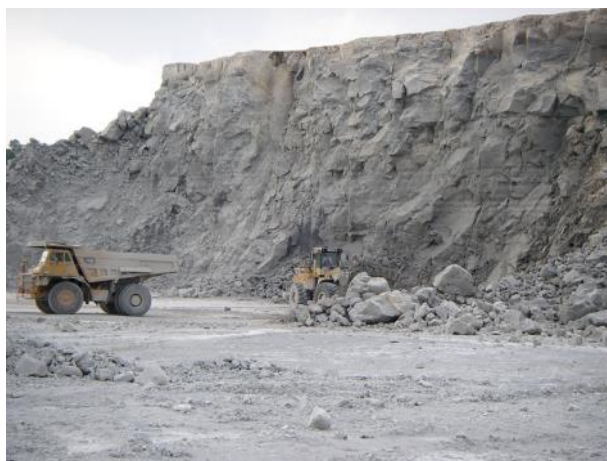
Figure 715. Dark and light banded layers, indicating oxic and anoxic deposition, in the Muldrow Member of the Demopolis Formation in a freshly quarried high wall of the Holcim Inc. Artesia Plant chalk quarry near Artesia in Lowndes County, Mississippi. Picture taken on August 24, 2007. Image 933.

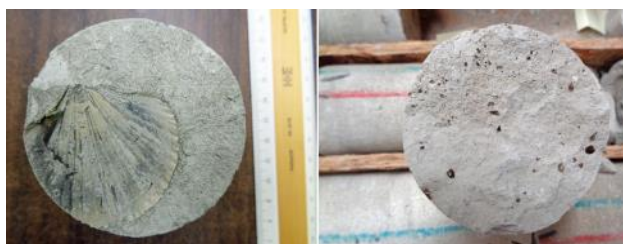
Figure 717. Bedding planes in the Cretaceous chalk core from Shuqualak, Mississippi, in MDEQ's Core and Sample Library in Jackson. At left is the fossil pecten *Neithea quinquecostata* and at right are biotite crystals (black) from a volcanic eruption at Jackson 75 million years ago. Image 2622.

from the eruption of the Jackson Volcano some 75 million years ago (**Figure 717**).

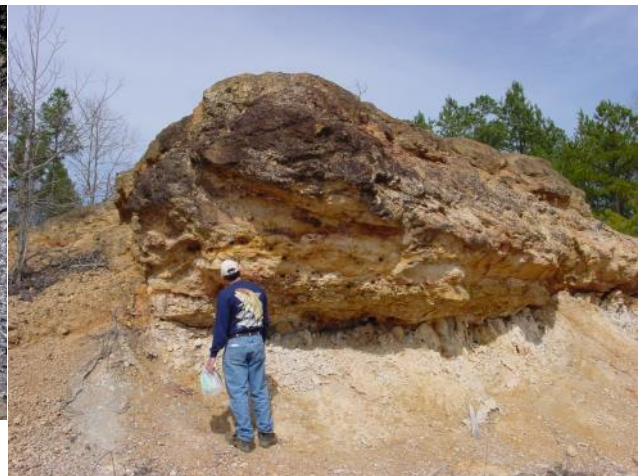
Figure 724. Ron Rose looking at bauxite overlying a kaolinitic clay in the weathered upper Oak Hill Member of the Nanafalia Formation in Pontotoc County, Mississippi. Picture taken by David Thompson. Image 2629,

mation in Noxubee County. **Figure 724** shows Ron Rose by a bauxite deposit in Pontotoc County.

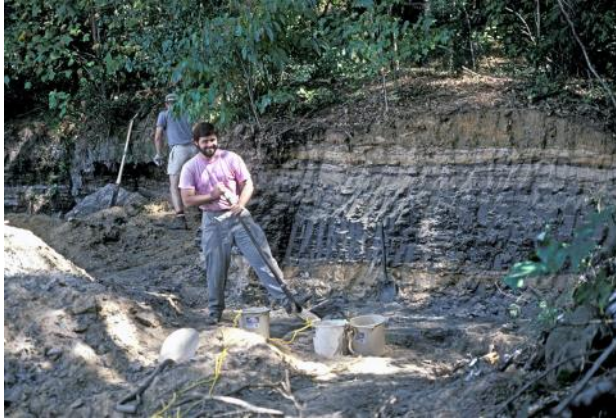
Figure 725. Chris Beard excavating the T-4 sand at the top of the Tuscaloosa Formation at the Red Hot Truck Stop locality in Meridian, Mississippi. In the excavation face above are Early Eocene fossil-leaf-bearing clays of the Bashi lowstand deposit. Picture taken on September 28, 1994. Image 119.

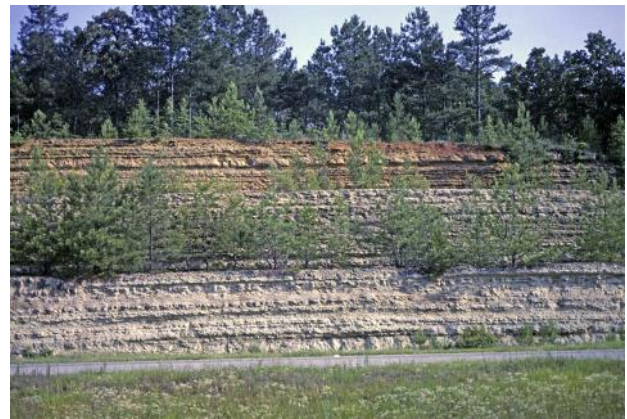
Figure 727. Tallahatta Formation in south-facing road cut on Interstate 20 west of Meridian, at Lost Gap in Lauderdale County. Picture was taken in June of 1974. Image 227.

the formation was named, a Native American name meaning “white rock” (**Figure 727**).

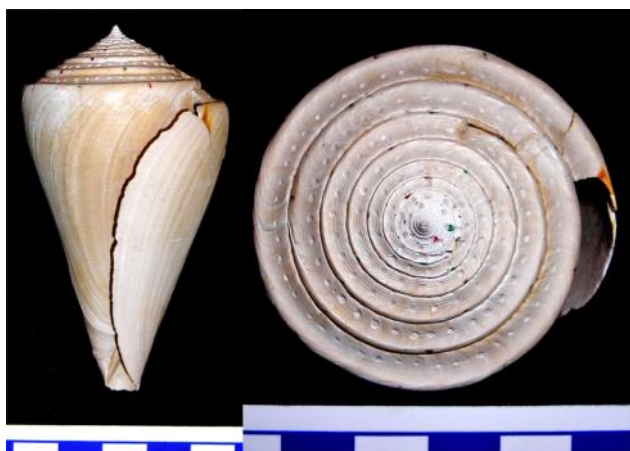
Figure 730. *Conus tortilis* from the Moodys Branch Formation at Town Creek (MGS locality 1) in Jackson, Mississippi, showing pits along spire where shell samples were taken for oxygen isotope analysis. Picture was taken by George Phillips on July 15, 2008. Image 1064b.

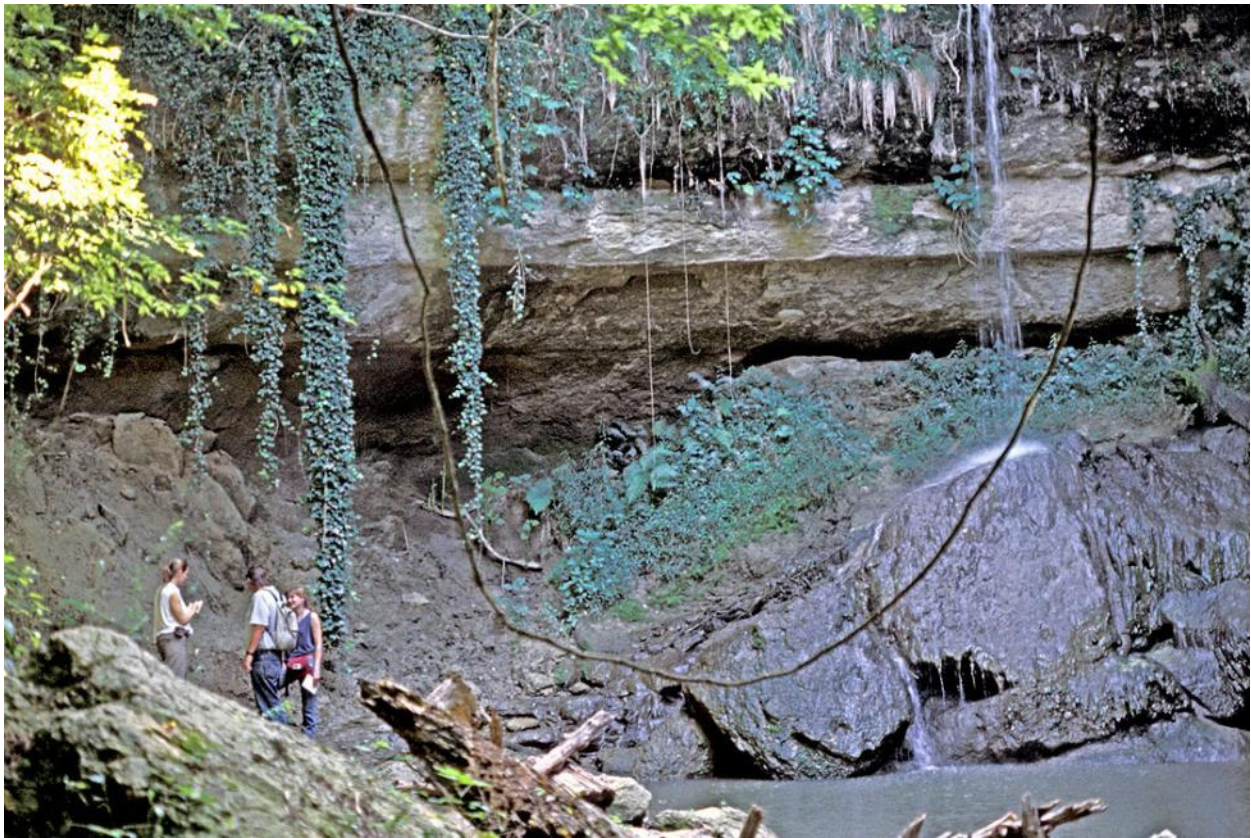
Figure 735. Mint Spring Formation at Mint Spring Bayou in the Vicksburg National Cemetery; left to right are Laura Stafford, Bruce Wilkinson, and Linda Ivany. The Mint Spring Formation is in the undercut below the lower ledge of the Glendon Limestone and softer underlying Marianna limestone. Picture taken on May 16, 2002. Image 48.

Oligocene Icehouse Earth. Linda Ivany et al. (2000) studied the isotope records of otoliths from the cusk eel *Ariosoma* from the Eocene and Oligocene of Mississippi and found that the surface water winter temperatures were colder in the Oligocene. One specimen from the Mint Springs type locality (**Figure 735**) had a seasonal range of 9.3°C

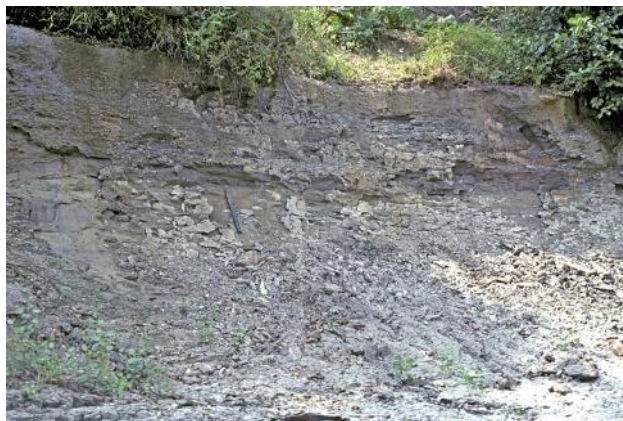
Figure 736. Contact of the light-gray Shubuta Clay and dark-gray Red Bluff Formation at MGS locality 34 on the Chickasawhay River in Wayne County. Picture was taken on September 7, 1978. Image 195.

(16.7°F). Ivany et al. (2000) attributed the colder Oligocene winter seawater temperatures to marine extinctions at the Eocene-Oligocene boundary (**figures 736-737**). Dockery (1986) recognized a 96.7 % extinction rate for molluscan species at the Eocene-Oligocene boundary in Mississippi.

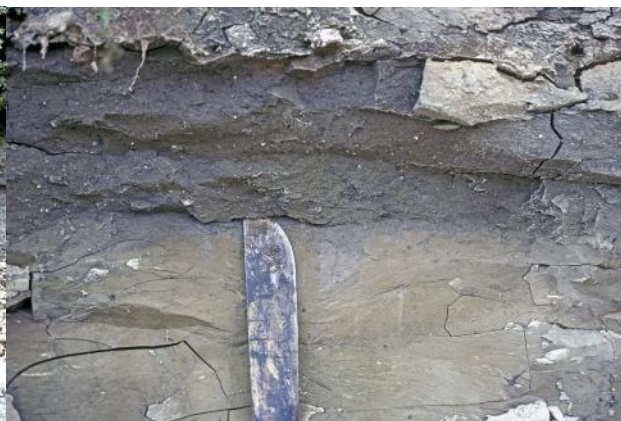
Figure 737. Contact of the Shubuta Clay and overlying Red Bluff Formation at MGS locality 34 on the Chickasawhay River in Wayne County. Picture (Kodachrome slide 51-19; Image 194) taken on September 6, 1978. Image 194.

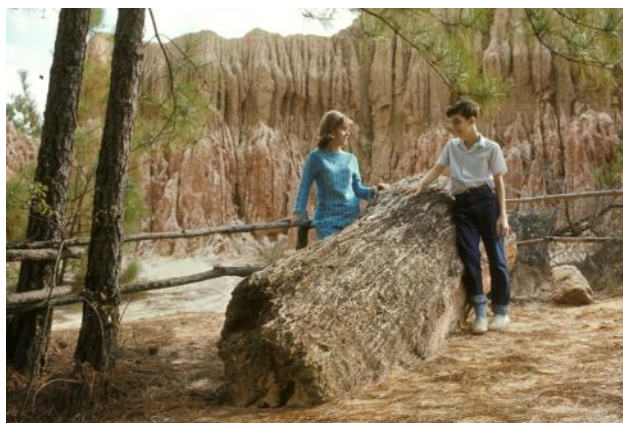
Figure 738. Beverly Schabillion and Jim Pitts beside a petrified log from the Forest Hill Formation in the badlands of the Mississippi Petrified Forest at Flora, Mississippi. Picture (slide from the Schabillion family; Image 1695) taken in November of 1965 by G. Holly. Image 780.

Mississippi Petrified Forest. Fossil wood in the Early Oligocene Forest Hill Formation contains giant logs (**Figure 738**) of sequoia, maple, fir, and spurge and such trees as *Cupressinoxylon florense* an extinct conifer related to the present day families Podocarpaceae and Cupressaceae, families living predominantly today in the Southern Hemisphere. According to Schabillion (1996) specimens of fossil wood from the Petrified Forest were sent to Francis M. Hueber, Associate Curator, Division of Invertebrate Paleontology and Paleobotany at the Smithsonian in 1962 for identification. The six specimens sent were determined to be angiosperms that lacked annular rings indicating a uniform climate. In July 1967, Virginia M. Page of the Department of Biological Sciences, Stanford University, California identified a specimen as *Abies* or Fir, a confirmation of earlier work. Other specimens

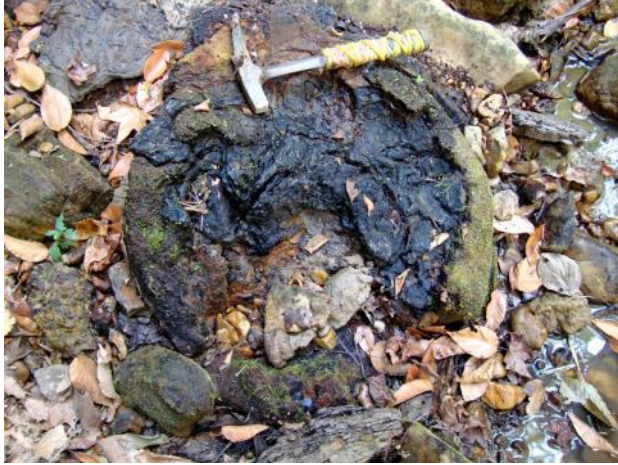
Figure 740. Petrified palm stump from the lignite bed in the Forest Hill Formation on Cold Creek in the NE/4, Section 25, T. 9 N., R. 4 W., Yazoo County, Mississippi. The stump's exterior is silicified, while the middle is lignitized. Picture was taken on September 9, 2010. Image 1703.

were members of the spurge family Euphorbiaceae, which lives today in southeast Asia. The petrified logs of the Petrified Forest were of much larger trees than those of living Asian spurge trees. **Figure 740** shows a partially petrified palm stump protruding from a lignite bed in the upper Forest Hill Formation in Yazoo County.

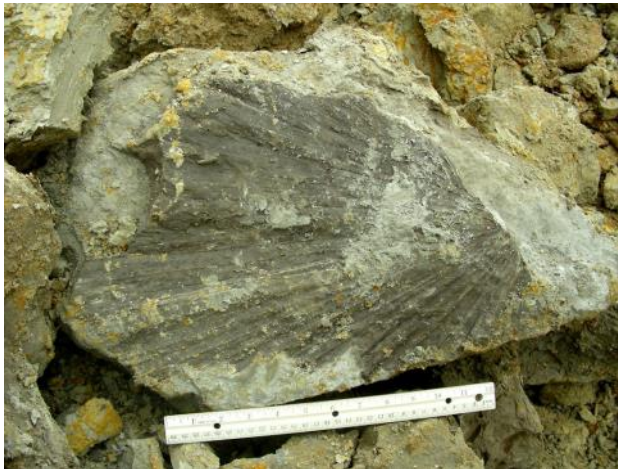
Figure 741. Fossil palm fronds at a fossil leaf locality (MGS locality 172) in a clay pit in the weathered Bucatunna Formation just east of Business Highway 61 and just south of MGS locality 140 in the Byram Formation in northern Vicksburg in Warren County, Mississippi. Picture was taken by Dana Link on March 30, 2008. Image 997.

Early Oligocene to Miocene Characterized by Coastal Palms. Fossil palm remains occur in the Glendon Limestone (**Figure 779**) and Bucatunna Formation (**Figure 741**) of the Early Oligocene Vicksburg Group, from
